AERIAL PHOTOGRAPHIC ANALYSIS OF SELECTED HAZARDOUS WASTE STUDY SITES

New Mexico and Texas

EPA Region VI

TS-AMD-82110a
April 1983

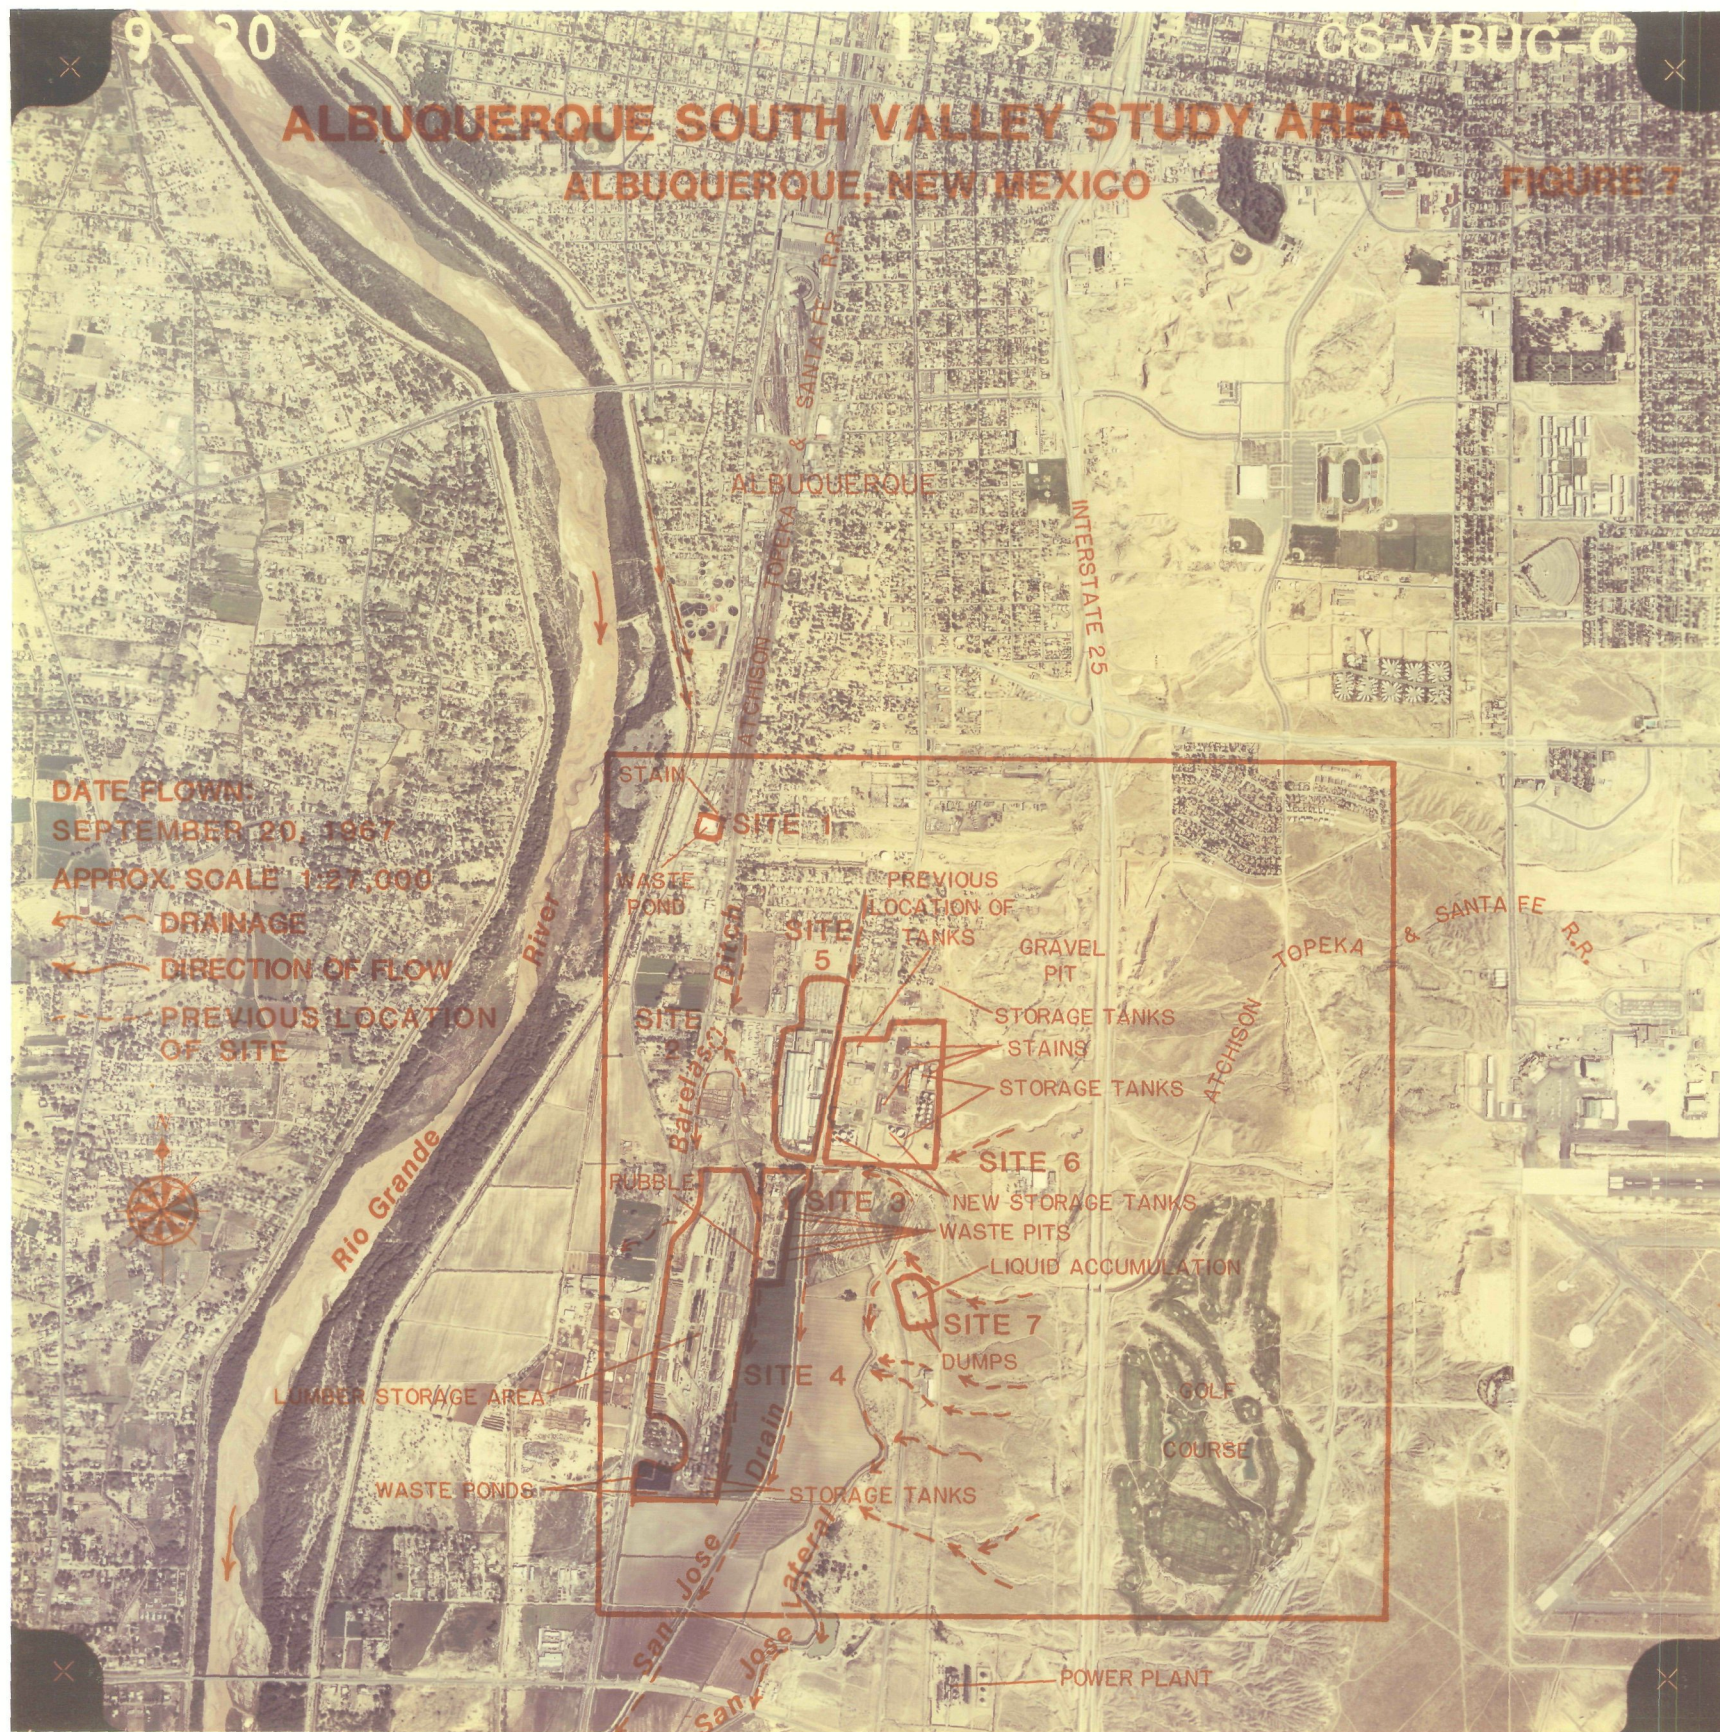
September 20, 1967, Photograph

The waste pond at Site 1 is filled with a substance that appears powdery (Figure 7). Some of the substance has spilled out of the waste receptacle, but threatens no drainages at this time. All tanks that were visible at the fuel distributor (Site 2) have been removed, and the site no longer exists. Five disposal pits are visible along the eastern edge of Site 3, one of which contains some unidentified objects. A collection of rubble is also present within the site.

Few changes have occurred within Site 4. Stacked materials that were present within Site 5 on the 1959 photograph (Figure 6) have been removed. Spill stains are visible at several locations within the bulk oil storage facility, Site 6, but there is no indication that spills have entered nearby drainages. Four uncontained storage tanks that were present within the bulk oil storage area on the 1959 photograph have been removed. Two additional storage tanks have been added to the site.

A small waste disposal facility, Site 7, was established within the study area between November 1959 and September 1967 (Figures 6 and 7). Several dumps and an accumulation of dark liquid, which appears to have been disposed of within the facility, are visible.

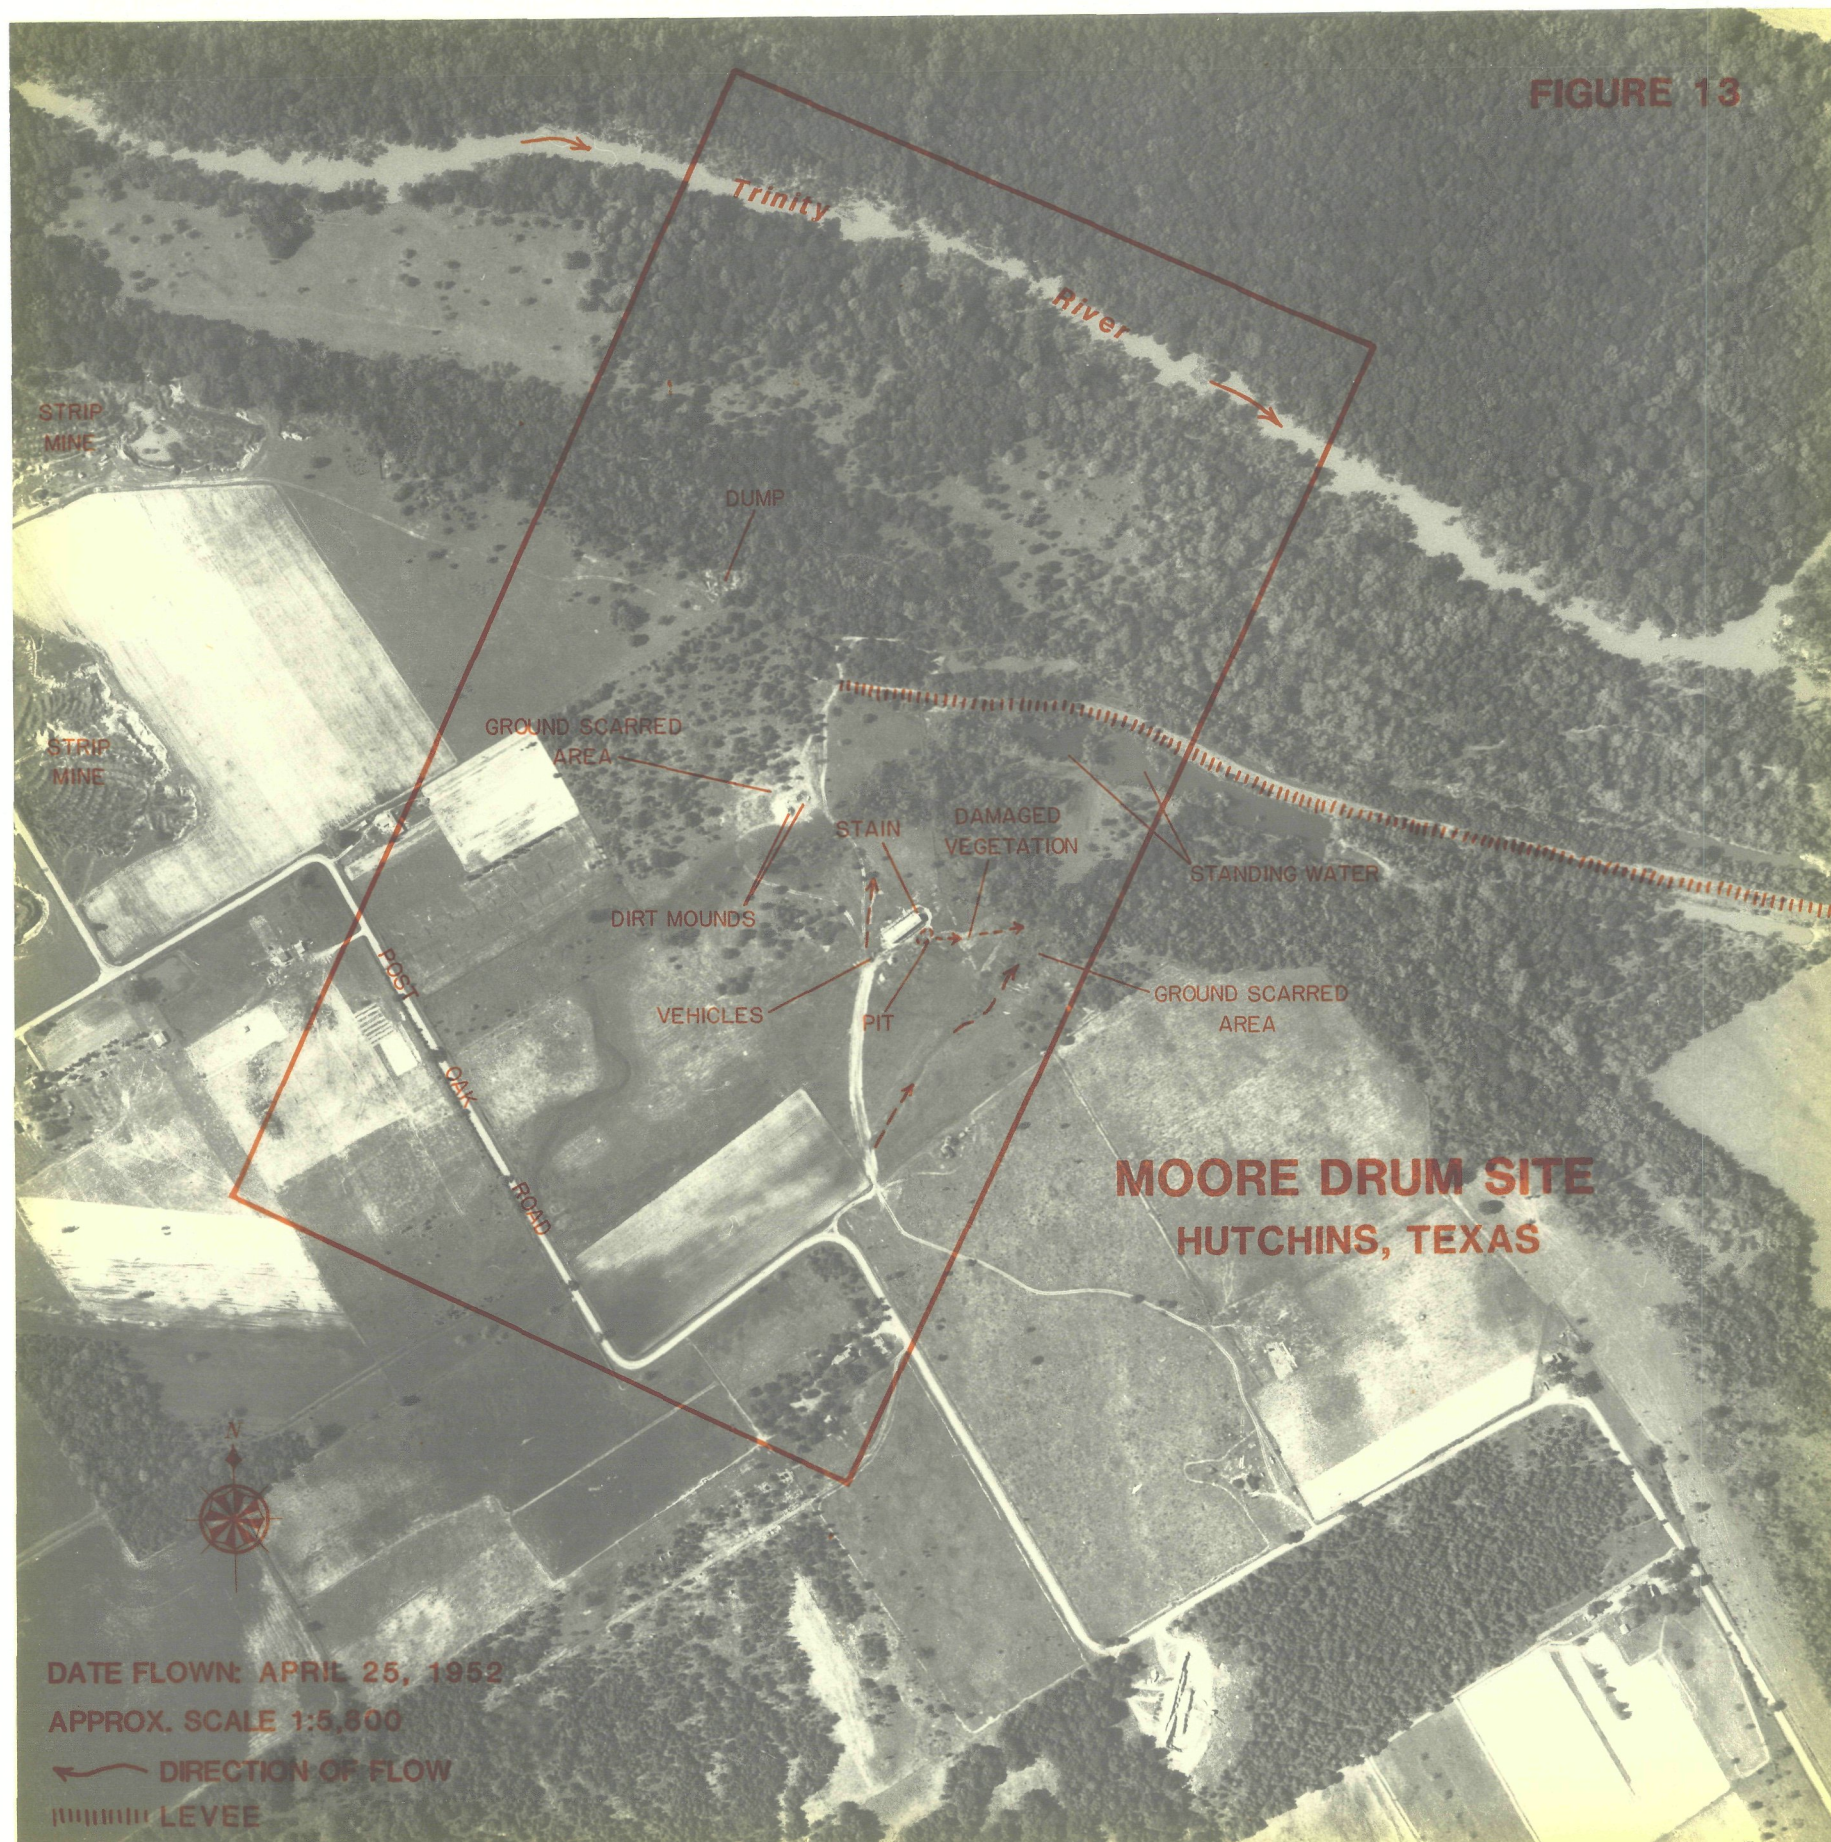
A stain is visible at the northwest corner of a warehouse-type building (Figure 13). A rectangular pit parallels the same building on its eastern side. Drainage leads away from this pit towards a ground-scarred area that has partially revegetated. Damaged vegetation that is visible along this drainage path suggests that liquid wastes may have flowed out of the pit into the ground-scarred area. A second ground-scarred area and an oil dumping area are also noted, northwest of the warehouse-type building. Two mounds of dirt, visible within the ground-scarred area, indicate that the area was probably active at the time that this photograph was collected. Scars are visible within the vegetation that has encroached upon the old dump.

Two accumulations of standing water are present within the study area. Drainage from the drum site could possibly flow into these accumulations. An earthen levee that is situated between the site and the Trinity River should prevent contaminated liquid from entering the Trinity River.

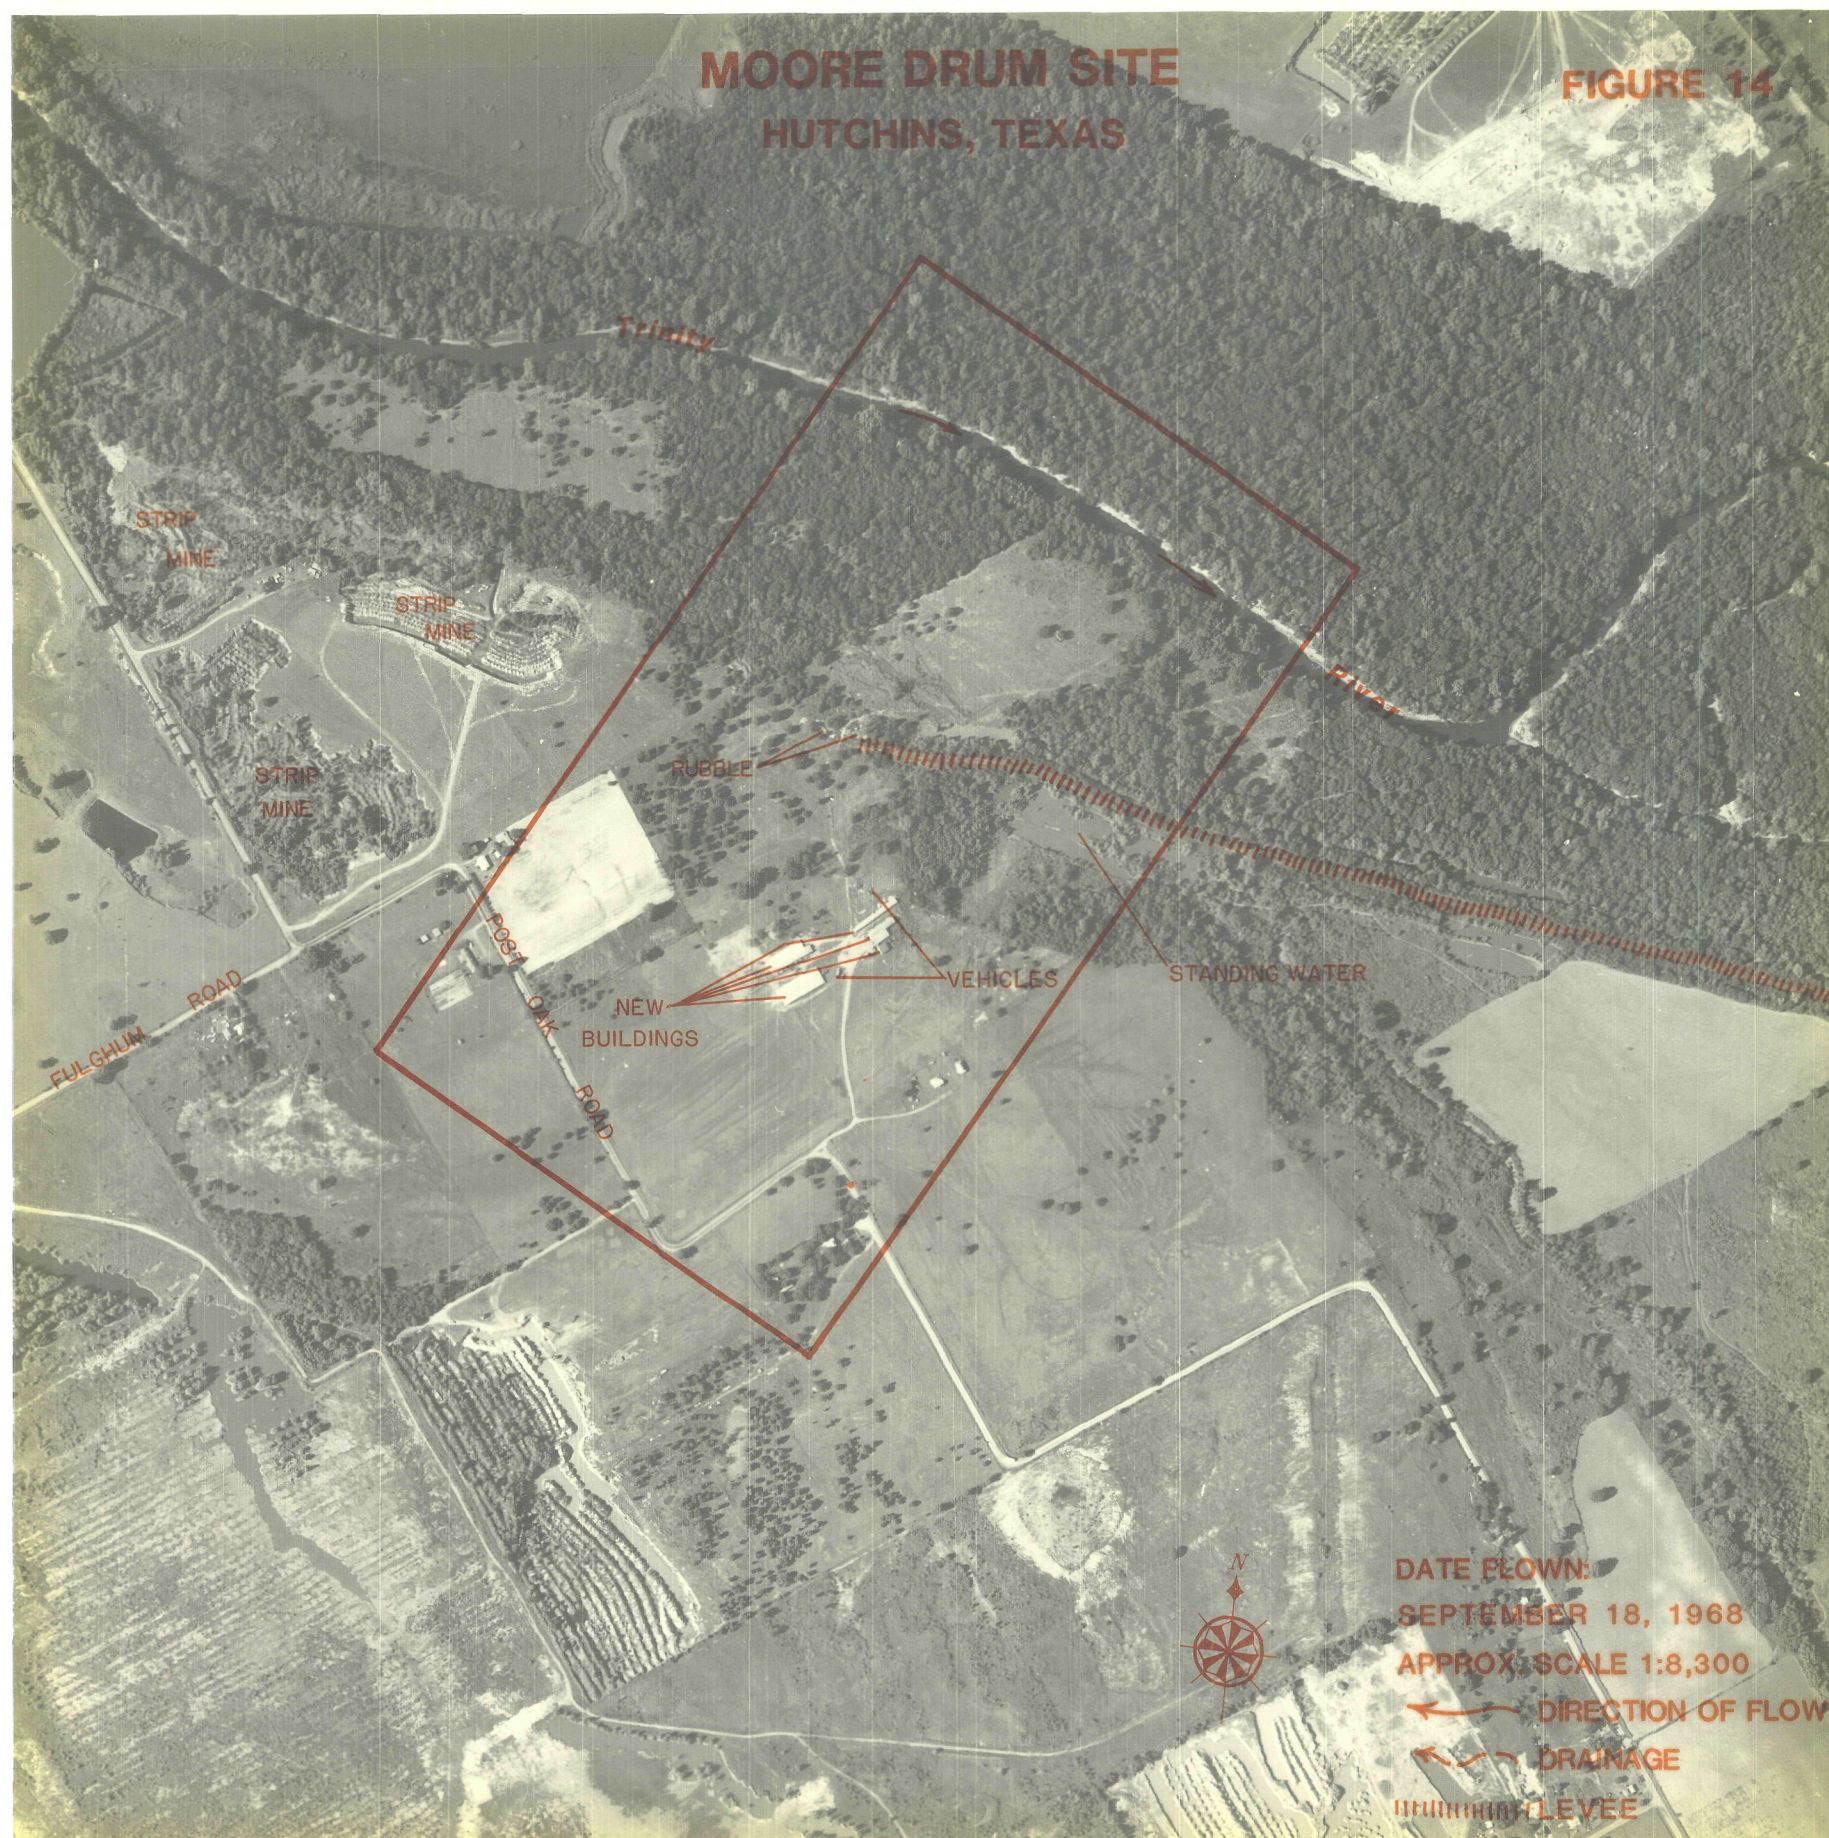
The warehouse-type building and an adjacent pit that were visible on the 1952 photograph are no longer present in Figure 14. Five new buildings have been constructed within the site, two of which are double-bay structures. Ground-scarred areas and an old dump which were also visible on the the 1952 photograph (Figure 13) have been overgrown with vegetation. Two piles of rubble that were not present on the 1952 photograph are noted within a dumping area.

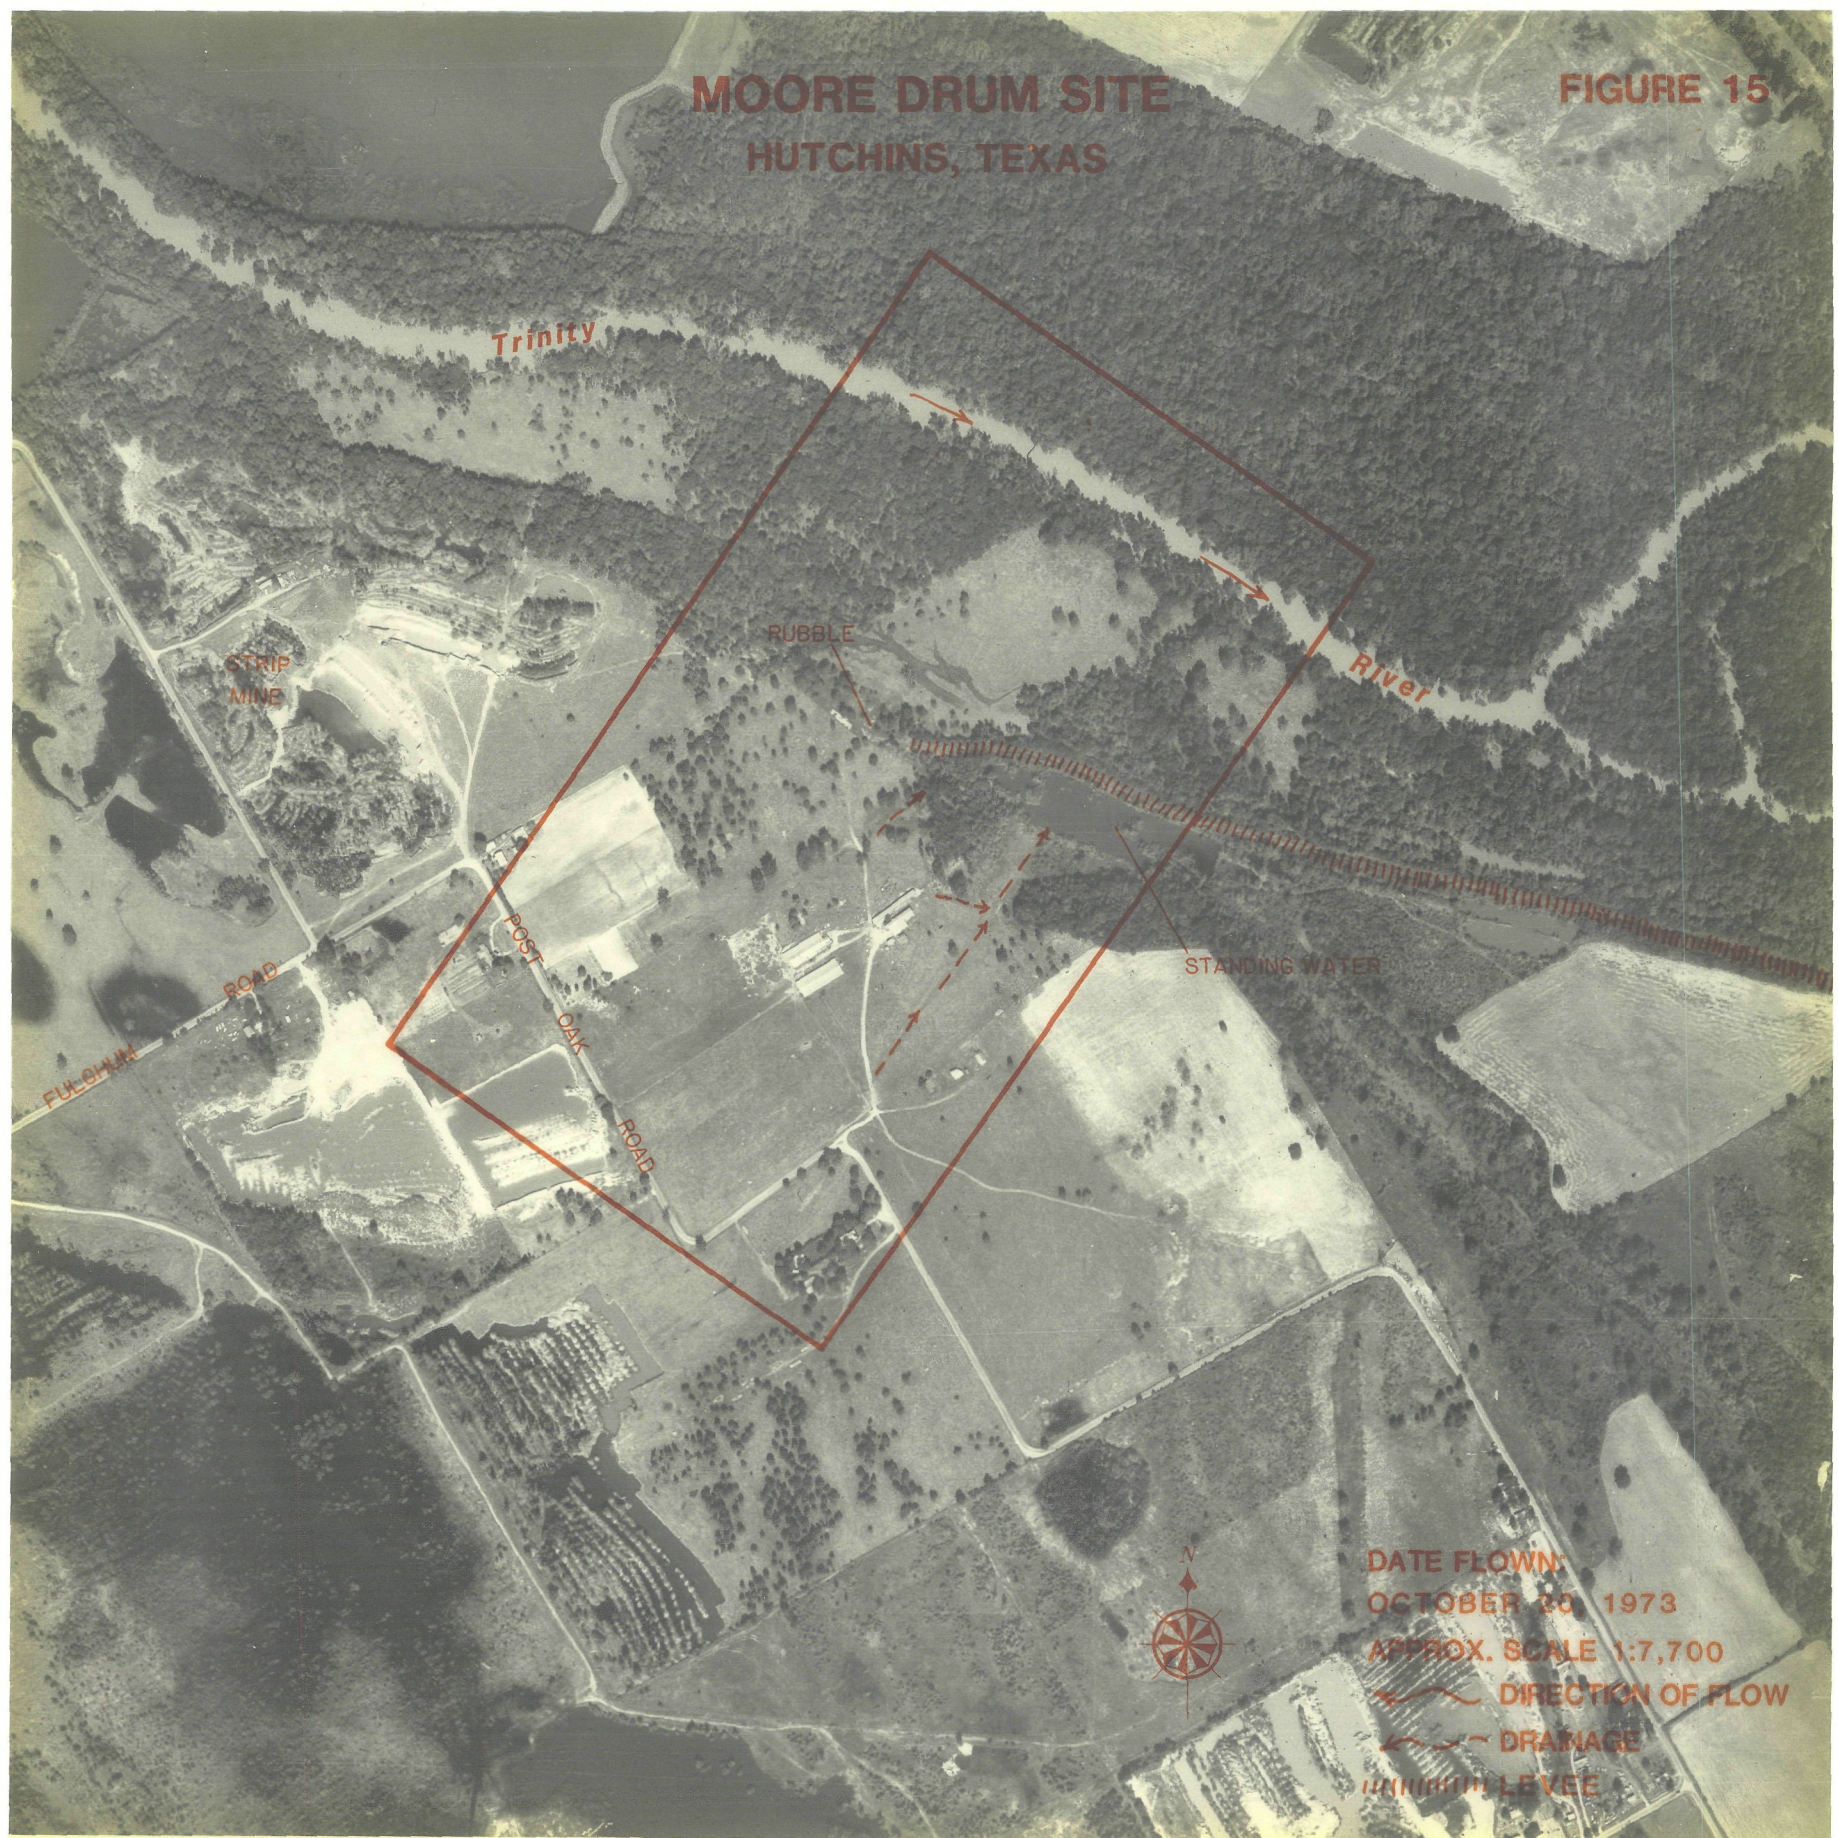
Few changes have occurred within the site subsequent to the September 1968 photograph (Figure 15). A single pile of rubble remains visible within a dumping area that was previously noted on the 1968 photograph.

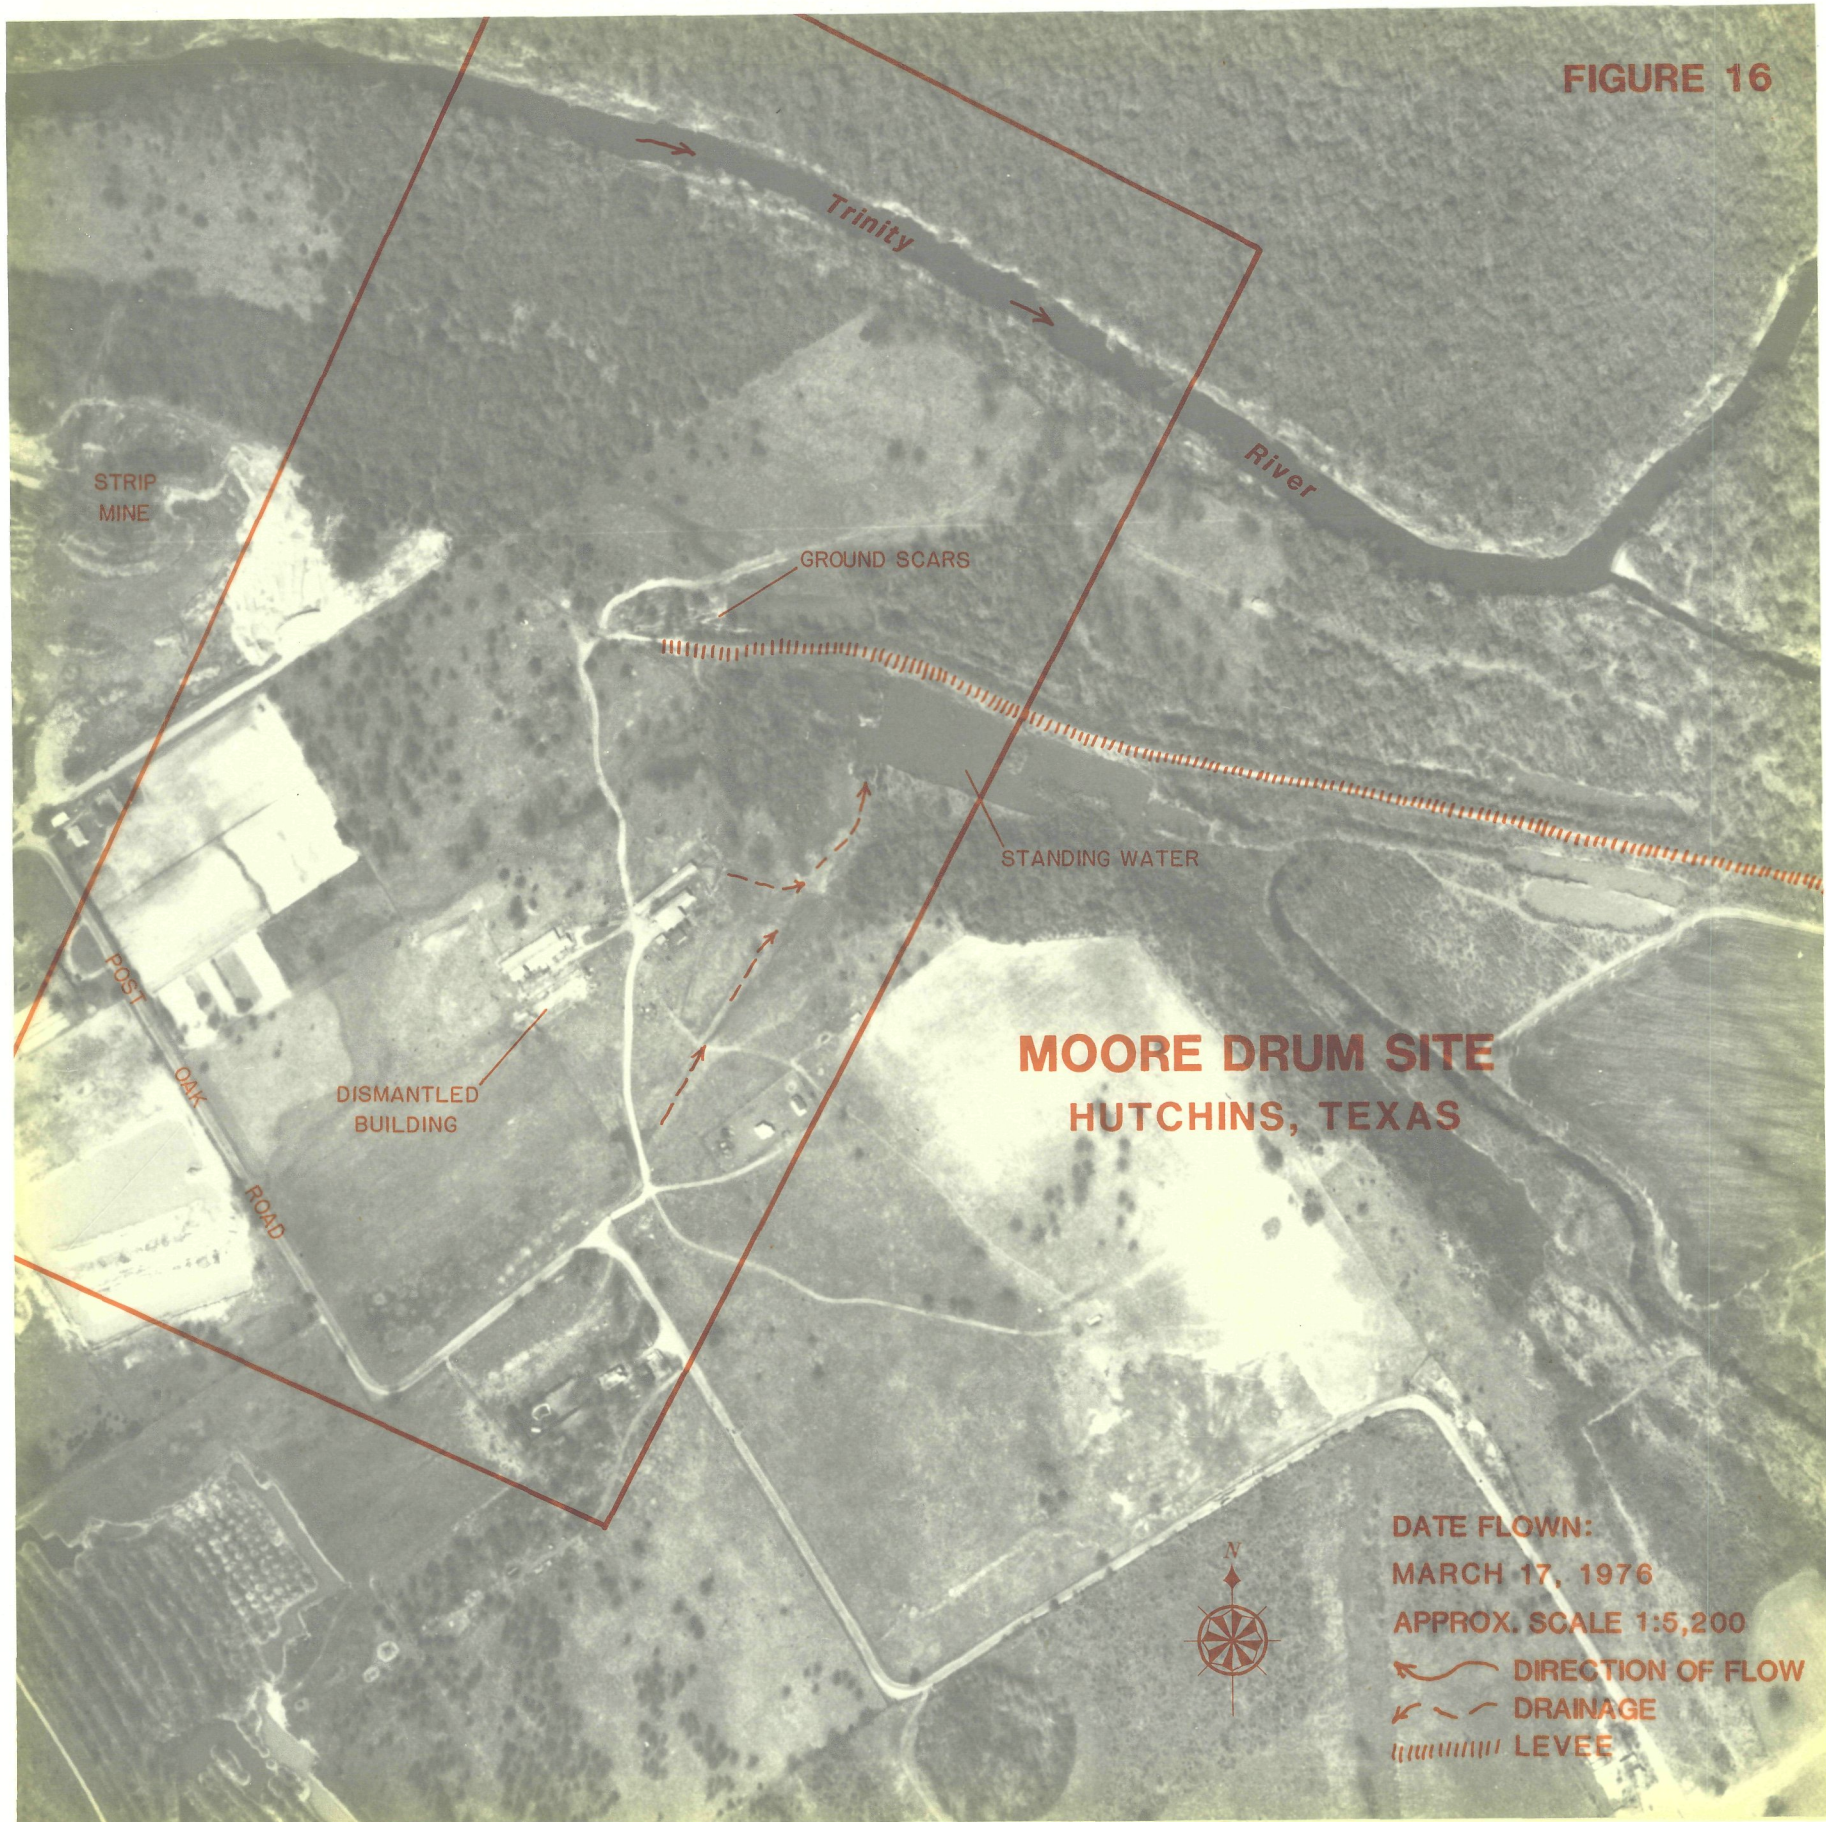
FIGURE 16

A building that was visible on the October 1973 photograph has been dismantled (Figure 16). No other structural changes have occurred within the site.

Ground scars are visible within an area in which rubble had previously been dumped (Figures 13 through 15). No rubble is noted at this time, and the area has continued to return to its former vegetative state.

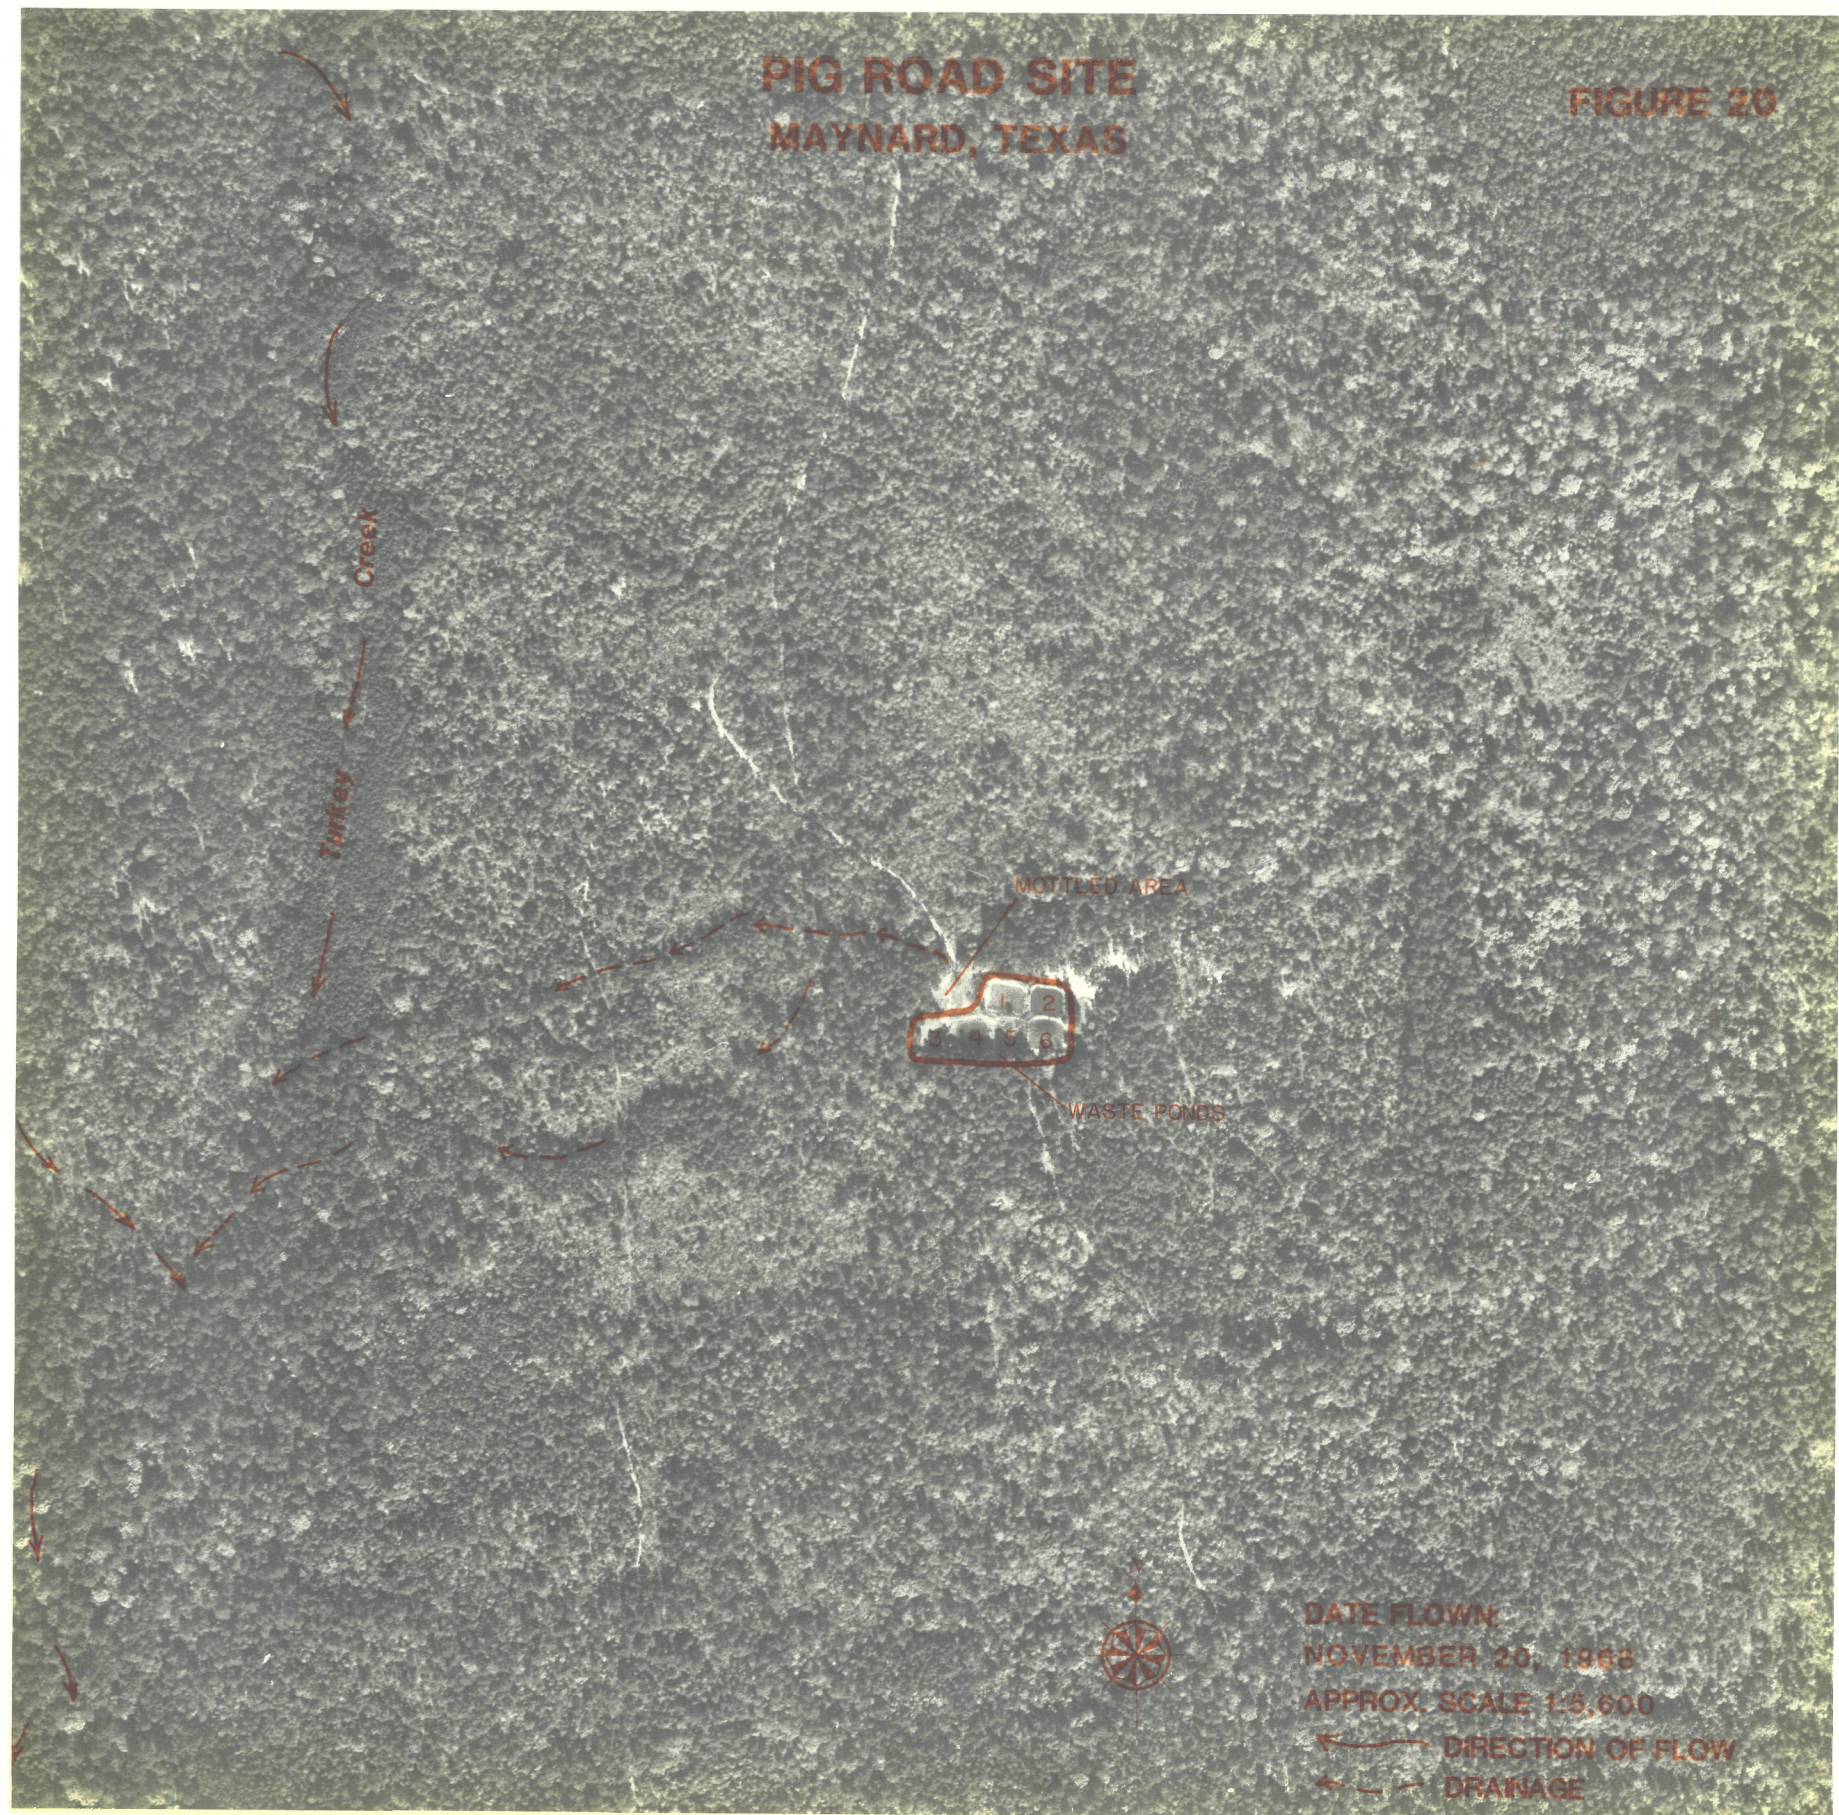
FIGURE 20

All waste ponds that were present on the December 1958 photograph (Figure 19) remain visible. For the most part, the ponds appear to contain less liquid than they did on the 1958 photograph.
